SAFETY CASE REPORT

ADDENDUM

Tihange 2

Reactor Pressure Vessel Assessment

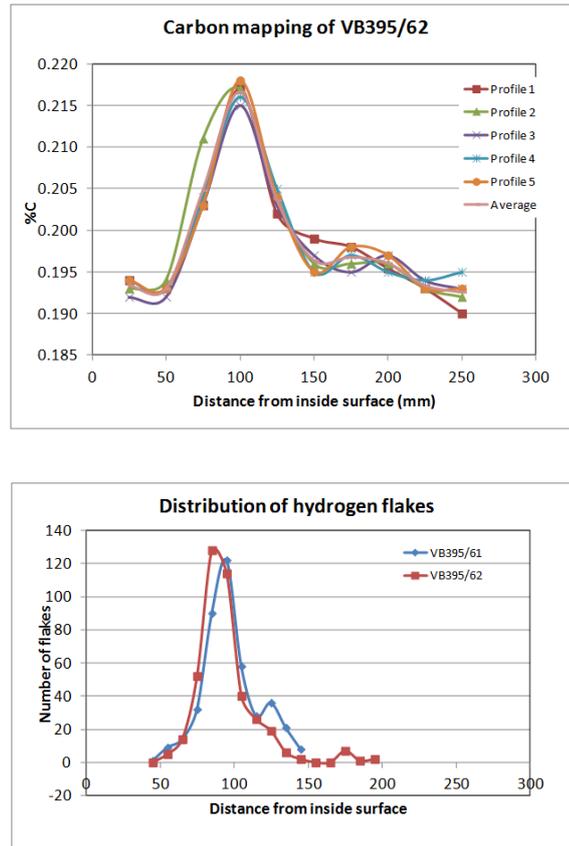
Figure 3.2: top: Carbon mapping, bottom: Distribution of indications in function of the position in depth

For the VB395/62 block, the carbon segregation profile has been compared to the distribution of flakes through the thickness, showing a one-to-one correspondence, as shown below. This confirms that the flaking occurs in macro-segregated areas.

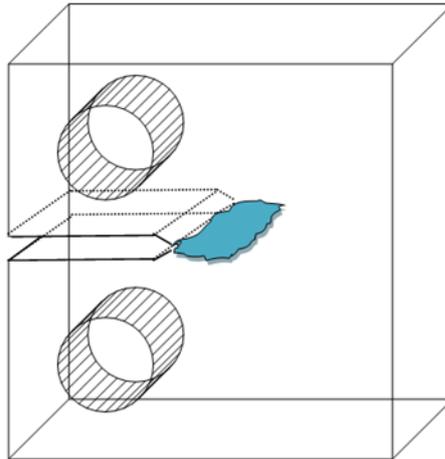
Figure 4.2: CT12.5 specimen with a hydrogen flake at the crack tip for direct measurement of toughness at the tip of the flake

- **Fracture toughness tests were performed on specimens with a hydrogen flake as crack initiator** (in place of the usual fatigue crack), as shown on the figure below. The preparation of such specimens is complex and these tests do not fulfil the standard requirements in terms of crack front regularity, however the measured values are confirmed by 3D Finite Element Analysis. The test results are close to the ones obtained on the ligament between flakes, with an increase of the Master Curve Reference Temperature T_0 of the order of 14 °C.

The total shift in RT_{NDT} is the sum of 11 °C, 14 °C and a value between 4 to 12 °C (corresponding to the spatial fluence variation in the RPV for the most critical flaw locations), covering a possibly higher irradiation embrittlement sensitivity of the macro-segregated zone. This total (between 29 and 37 °C) is well within the 50 °C margin on the RT_{NDT} considered in the Structural Integrity Assessment.

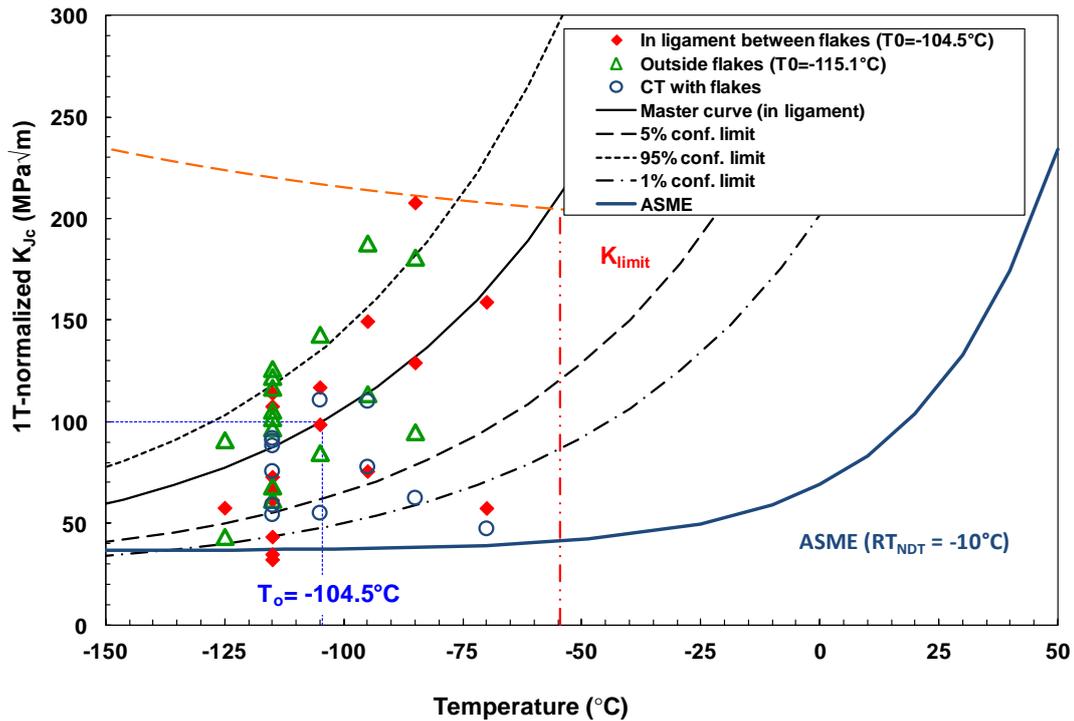
Figure 4.3: Comparison of fracture toughness of the VB395/61 material in the ligament between flakes and in the material free of flakes

- The fracture toughness properties of the material in the ligament between flakes are comparable to the properties of the material in the zone free of flakes.
- The fracture toughness tests on specimens with hydrogen flakes as crack initiator (instead of the usual fatigue crack) are not strictly valid according to the standard, but can nevertheless be used. They confirm that there is limited difference with the specimens taken from the ligaments between flakes.

- All results are compared in the figure below. For clarity only the Master Curves for the specimens taken in the ligaments between flakes are represented. All results are enveloped by the ASME curve indexed on the RT_{NDT} of this material, except for two points at very low temperature ($-115\text{ }^{\circ}\text{C}$), which are not relevant with regard to operating conditions.
- The surveillance results for the Doel 3 and Tihange 2 RPVs have shown that the effect of embrittlement, as evaluated by the FIS formula, is conservative. This led to a margin of 10 to 25 $^{\circ}\text{C}$ which is not taken into account in the evaluation.
- The results confirm the conservativeness of the 50 $^{\circ}\text{C}$ margin on RT_{NDT} considered in the structural integrity analyses.

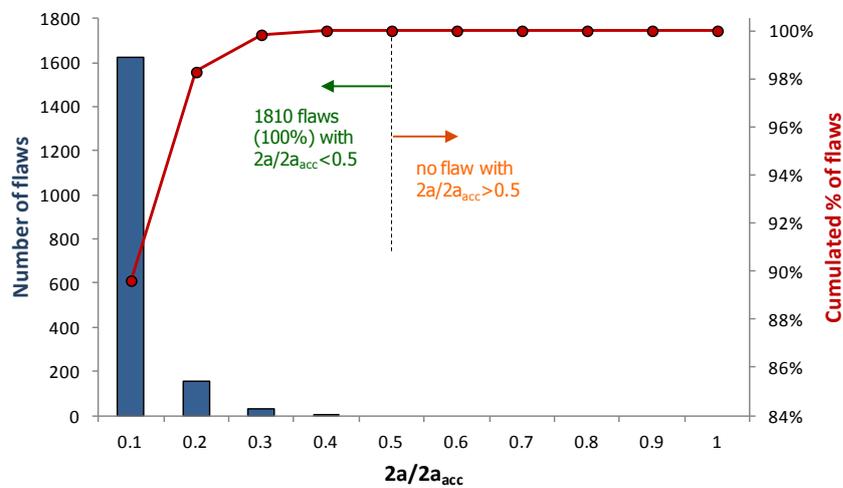
Figure 5.2: Flaw-screening criterion applied to core shells of Tihange 2

Applying the flaw-screening criterion to the flaws detected in the RPV core shells of Tihange 2 shows that none of the flaws exceed the flaw-screening criterion, as illustrated here:

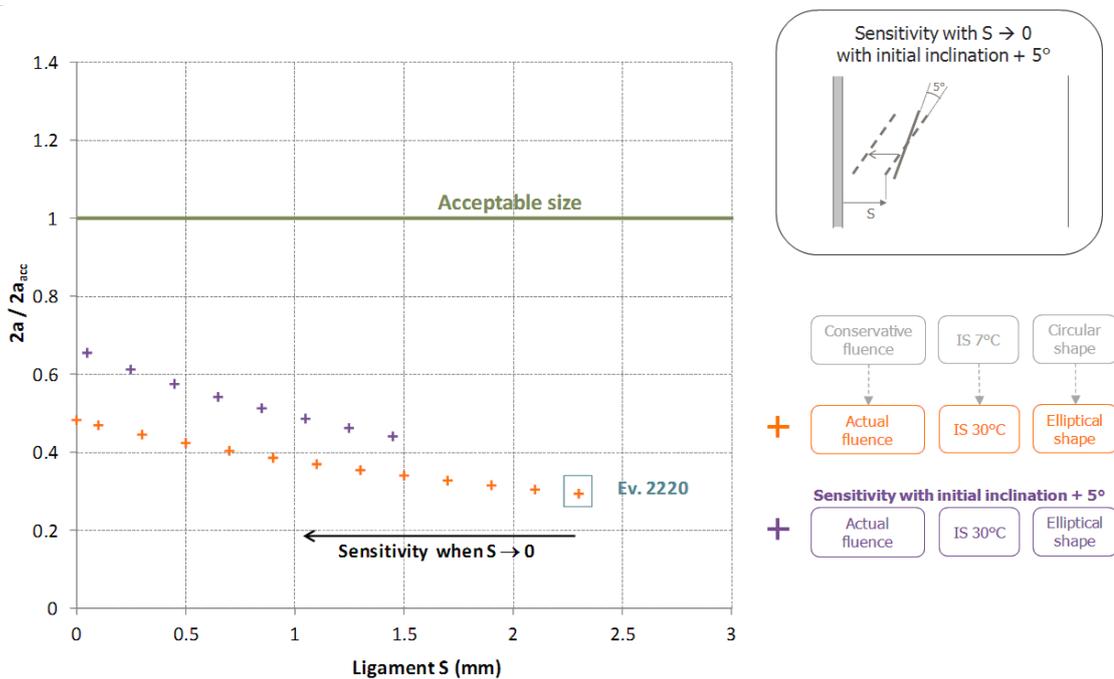
Figure 5.3: Sensitivity analysis for S→0 combined with effect of a 5° increase of the inclination of the Doel 3 flaw (Ev2220)

A number of sensitivity analyses were performed on the most penalizing flaw of the two RPVs (Doel 3 flaw Ev2220), considering effects such as the ligament tending to zero, a 5° larger inclination, the actual fluence, the flaw shape, and the Safety Injection water temperature. Results confirm that a significant margin remains in all cases. This figure shows the evolution of the margin with respect to the acceptability criterion with the ligament S tending to zero.

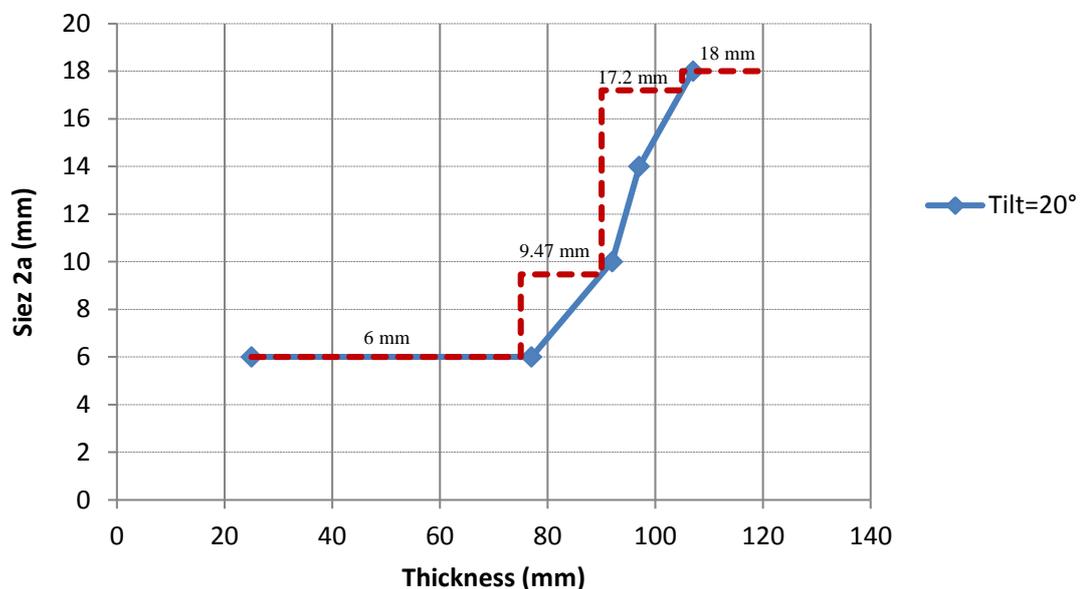
Figure 5.4: Size of largest potentially unreported higher tilted flaw (20° tilt)

The outcome of this action is the solid blue line in the Figure below. It is an envelope curve that defines the size of the largest flaw with a 20° inclination that would potentially not have been reported, as a function of the position in the RPV wall in the depth range between 25 and 120 mm.

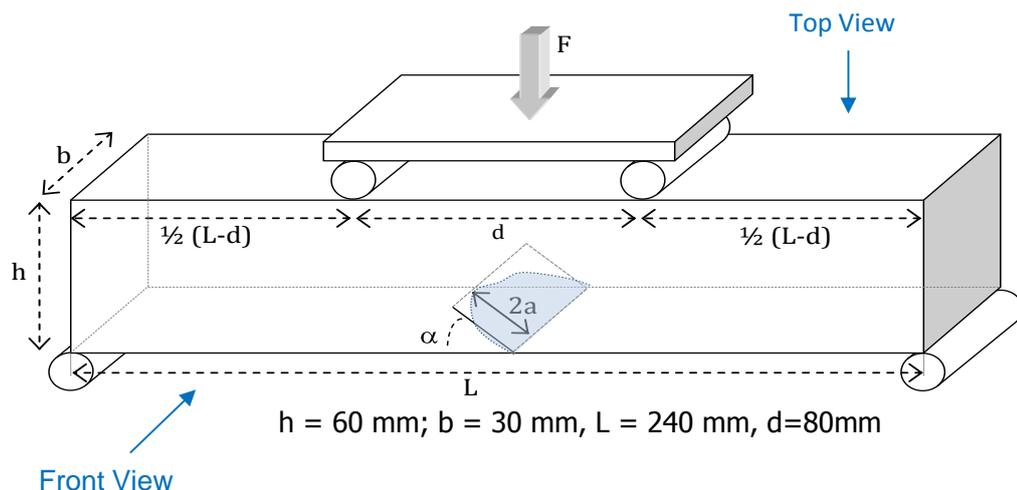
Figure 5.5: Four-point bend specimen with surface breaking flake

Two bend bars containing several flakes and a least one surface-breaking flake covering the whole width of the specimen, were extracted from the VB395/62 block.

The actual four-point bending tests yielded failure loads well above the predicted values, and hence confirmed the conservativeness of the analysis:

The large difference between calculated and experimental failure load for the second specimen is due to the fact that the real flake is considerably smaller and less inclined as compared to the modelled flake. Taking into account the actual dimension and inclination of the flake, a new simulation yielded a calculated failure load of 189 kN which is much closer to but still below the experimental failure load.

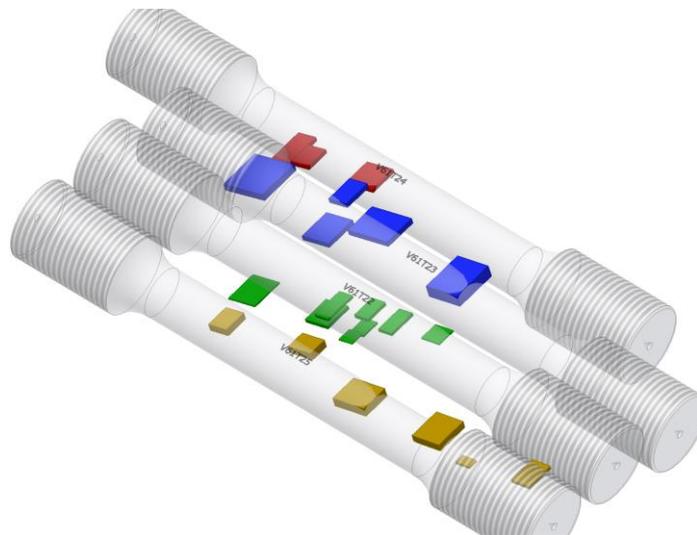
Figure 5.6: 3D view of the tensile test specimens with flakes tilted 20° with respect to specimen axis. The flakes are represented by coloured boxes that envelope the actual flakes.

The two specimens tested at room temperature broke after plastic deformation (3% and 5.3% uniform elongation). Since SIA is performed in the elastic domain, these tests are not used for validation of the 3D Finite Element Analysis.

The two specimens tested at -80 °C broke shortly after reaching the (engineering) yield stress at this temperature (600 MPa), without significant gross plastic deformation. A detailed 3D Finite Element analysis demonstrated that there is no premature brittle fracture and that the specimen fracture was predictable.

In both specimens tested at -80 °C, the equivalent stress intensity factor at the tip of the flake where the failure occurred was well above the lower bound fracture toughness. This means that the actual fracture occurred at a load well above the calculated failure load and at the location predicted by the 3D Finite Element Analysis. This demonstrates once more that the 3D Finite Element analysis is conservative with respect to the experiments.
