**REPORT ON INDEPENDENT  
ANALYSIS AND ADVICE  
REGARDING THE SAFETY CASE**

# **Tihange 2**

## **Reactor Pressure Vessel Assessment**

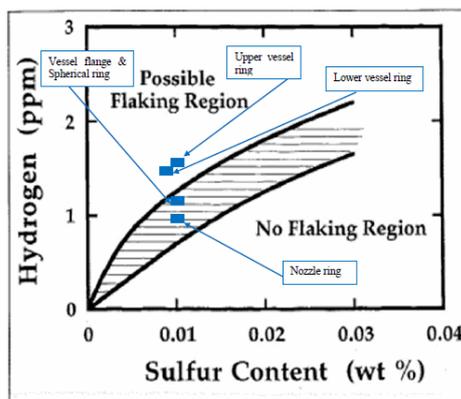
The following chart illustrates the above statement specifically regarding the influence of the concentration of sulphur—one of the most important chemical parameters for hydrogen flaking—in the forged pieces of the Tihange 2 RPV (the actual amount of sulphur measured by Krupp is lower than the specified value of 0.02 wt%). This led AREVA (in the 1980's) to specify a maximum hydrogen concentration of 0.8 ppm to avoid the risk of hydrogen flaking.

Although the chart above (R. J. Fruehan, *Iron & Steelmaker*, 1997)—adapted to the specificities of the Tihange 2 RPV—is mainly indicative, both the upper and lower shells of the Tihange 2 RPV shell are in the possible flaking region.

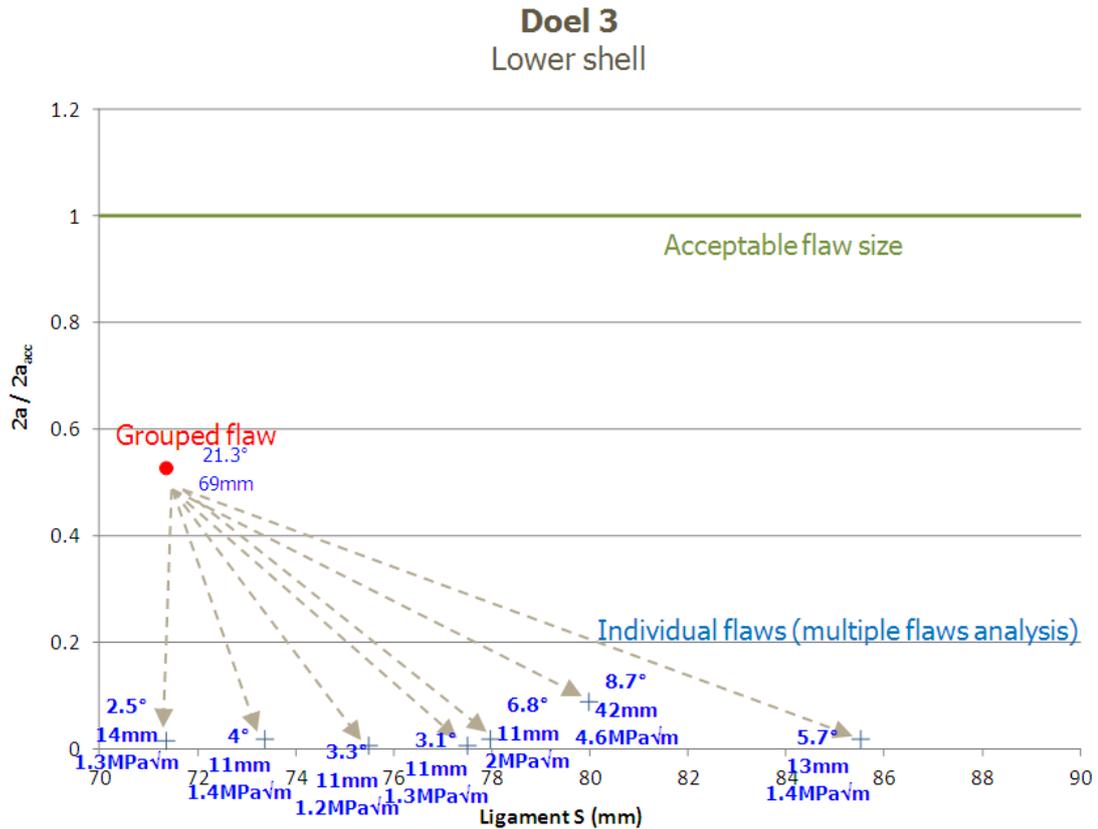
- The three groups closest to the cladding in the elastic-plastic zone and closest to the maximum allowable size before facing a crack initiation risk (see picture in Chapter 4.5.2).
- A group containing a large number of flaws (7) in the linear elastic zone.

The results of such 3D calculations for the 7 ungrouped flaws show a significant increase of the margin with respect to the maximum allowable size. Similar conclusion is also valid for Tihange 2 grouped flaws.

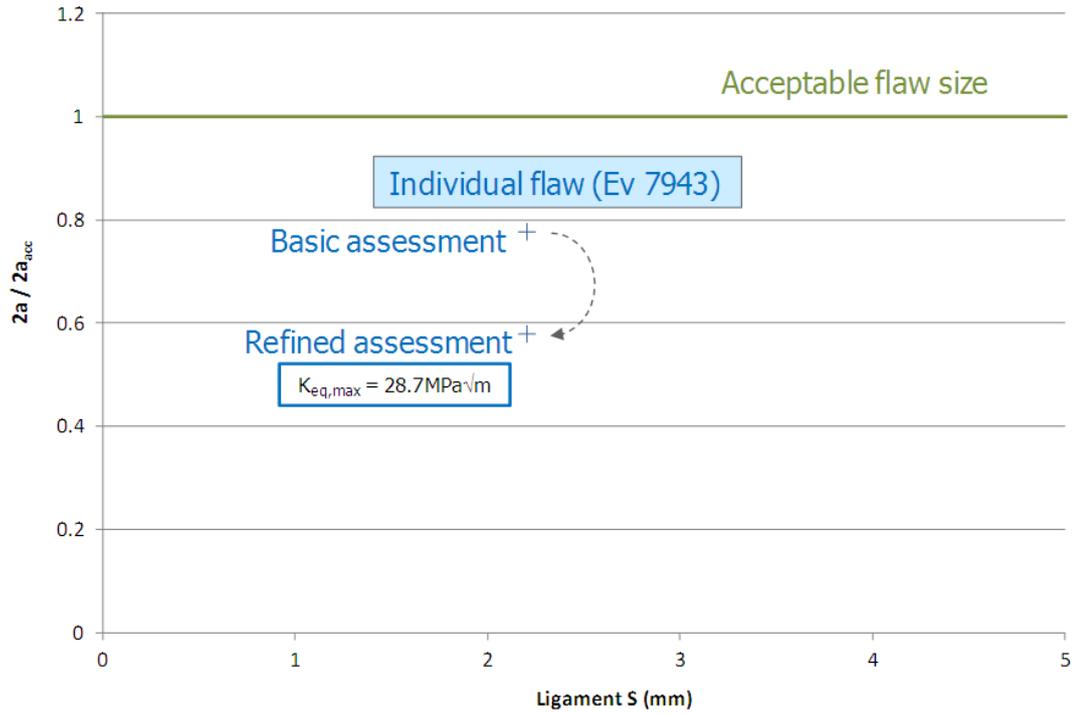
SNL has shown that considering such flaws in isolation can be non-conservative for some configurations of closely-spaced flaws. SNL recommended that flaws that have been deemed acceptable in isolation by the Project Team be reassessed in light of the effect that neighbouring flaws may have on them. In order to address this concern, the Project Team assessed the influence of the environment on ungrouped flaws through 3D analysis of the two individual flaws closest to the maximum available size. One result for Doel 3 is shown in the picture below where the refined assessment shows a significant additional margin:

In light of the results, SNL concludes that the Project Team approach is reasonable and that it will ensure the adequacy of the methodology. The SCP Review Team agrees with this conclusion.

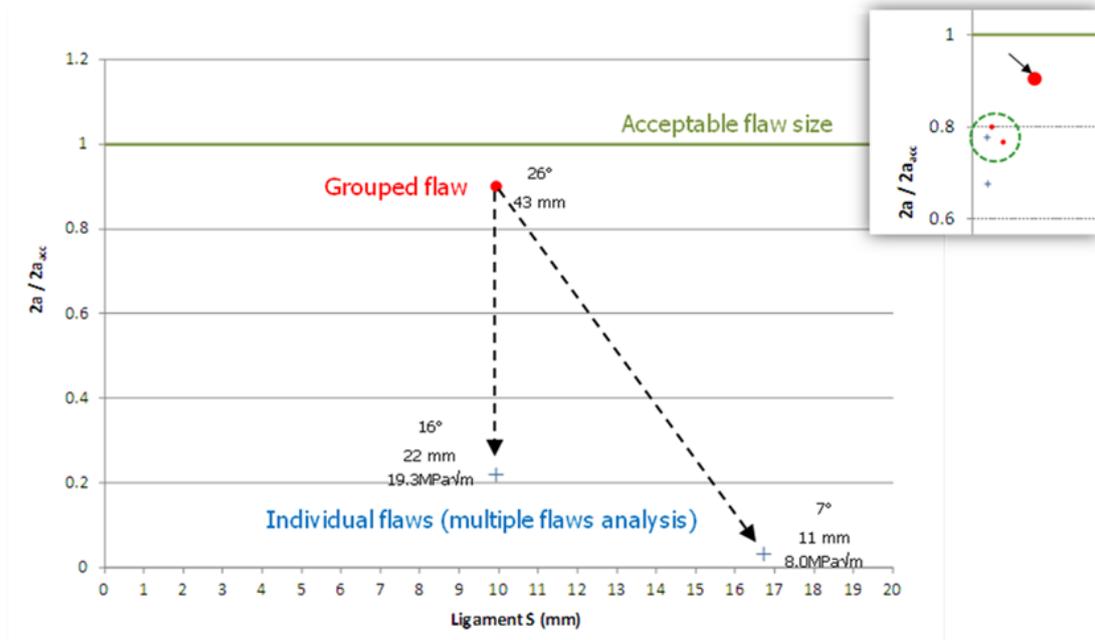
The Project Team has clearly demonstrated that the only cases for which this question was relevant were acceptable. The relevant cases are the ones in which the flaws (grouped or isolated) are close to the maximum allowable size before facing a crack initiation risk, according to the ASME values. For the flaws close to this limit value, calculations have been made by the Project Team to quantify the impact of the grouping criteria and the surrounding flaws. To perform those calculations, the grouped flaws have been un-grouped. The set of un-grouped flaws has been evaluated through 3D calculations. The results were completely satisfactory, showing that the grouping criteria used were acceptable and offered a large margin versus allowable size, as shown in the graph below.

Similar 3D calculations were performed for the most critical isolated flaw, with similar results. The potential lack of conservativeness due to the neglected influence of the surrounding flaws on the calculated flaw, was largely compensated for by the over-conservativeness of the flaw grouping methodology.

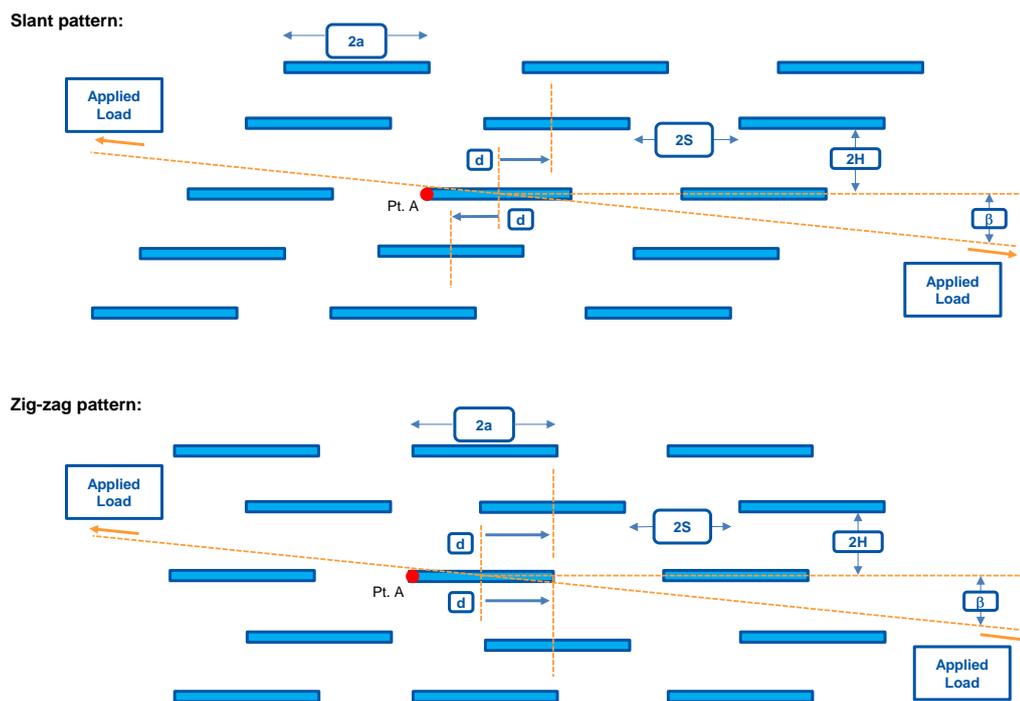
Two-dimensional analyses involving a group of equally-sized, uniformly-spaced planar circular flaws were performed by SNL to investigate the role of flaw configuration and spacing on fracture criticality, as well as to identify the more penalizing flaw configurations for the three-dimensional finite element analyses.

A group of 5 by 5 (25 in total) equally-sized flaws in various configurations was assessed. Two flaw patterns were investigated, slant and zig-zag (see Figure above). Four intra-row (within a single row) flaw spacings ( $S/a$ ) were investigated: 0.5, 1.0, 1.5, and 2.0. For each intra-row spacing several inter-row shifts ( $d/a$ ) were investigated that span the entire range of possible shifts.
