SAFETY CASE REPORT

ADDENDUM

Tihange 2

Reactor Pressure Vessel Assessment

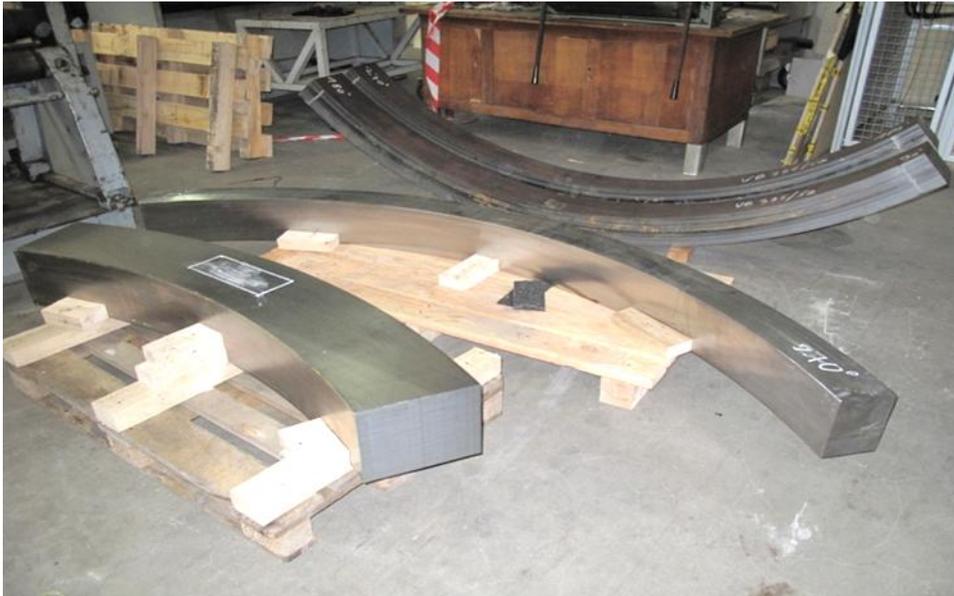
Figure 4.1: Blocks from AREVA shell VB395

An extensive testing program was performed on different blocks extracted from the VB395 shell, both in a zone free of flakes (as reference) and in a zone affected by flakes. A total of 172 specimens of different types were tested.

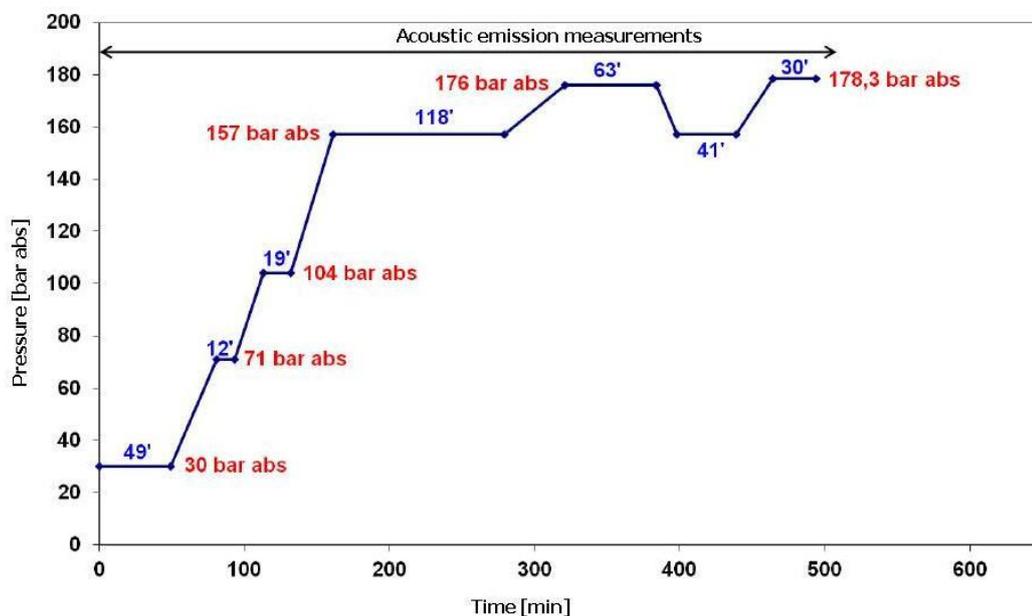
Figure 6.1: Primary pressure evolution during the load test

The primary pressure evolution during the load test was in accordance with the Electrabel procedure and AE requirements and is given in Figure 6.1. There were two test plateaus at about 176 and 178 bar abs of respectively one hour and 30 minutes separated by a lower plateau at 157 bar abs. This enabled the detection of potential AE reactivation at a lower pressure level.

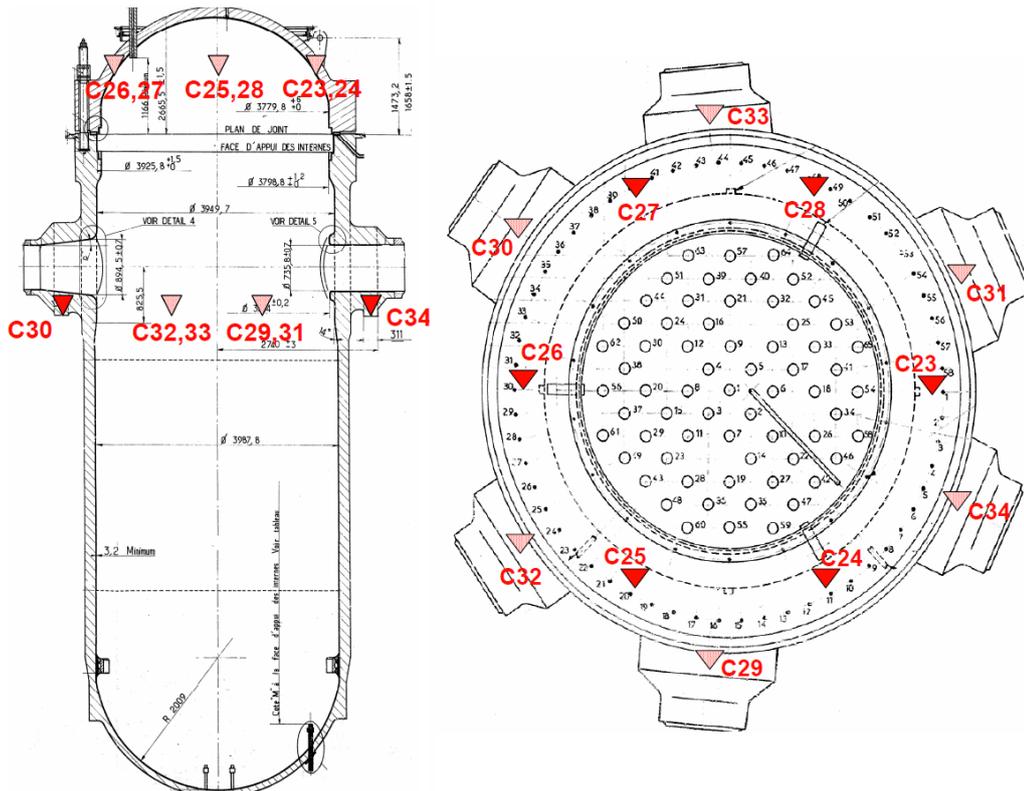
Figure 6.2: Location of the sensors on the RVH (C23 to C28) and on the RPV nozzles (C29 to C34)

The goal of the Acoustic Emission (AE) test was to detect the propagation of flaws in the RPV core shells, if any. In order to reach this objective, the Tihange 2 RPV was equipped with fifteen sensors (see Figure 6.2):

- Six sensors on the Reactor Vessel Head.
- Six sensors on the RPV inlet and outlet nozzles.
- Three sensors on the in-core instrumentation connected to the bottom of the RPV.
